REHABILITATION OF NAVIGATION LOCK WALLS: CASE HISTORIES

James E. McDonald

Structural Laboratory

December 1987

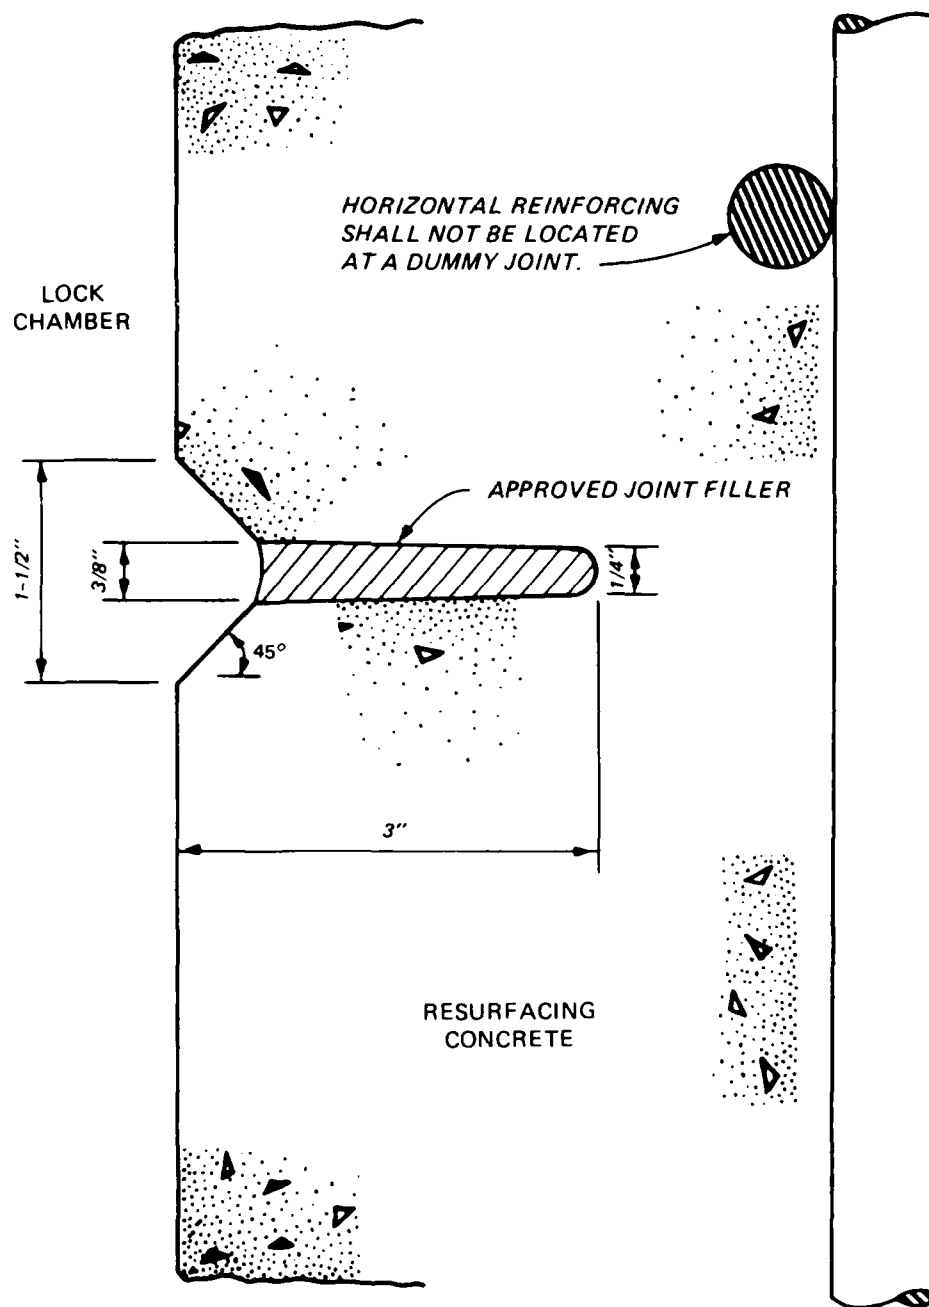
performance were reviewed, and no major deficiencies were found. However, based on results of the trial resurfacing and Corps experiences with other lock wall resurfacing projects, it was anticipated that cracks would occur. In an effort to control such cracking, horizontal dummy joints 5 ft on centers were specified. These joints were specified to be a minimum of 3 in. deep (Figure 94) and to align with horizontal joints in the reconstructed tainter valve monoliths. Vertical joints were not specified because it was thought that they would be more vulnerable to barge impact. One of the resident engineers was assigned sole responsibility for monitoring the concrete placement and quality control to assure that good construction practices were followed within the limits of the specifications.

Figure 94. Horizontal dummy joint design, Lock No. 1, Mississippi River

226. The dummy joints appeared to be controlling horizontal cracking. One disadvantage of the dummy joints is that their depth (3 in.) is such that the reinforcing mat located 5 to 6 in. from the lock wall face reduces its effectiveness in crack control. It would have been preferable to maintain a maximum of 4-in. cover, which could have been obtained by using a smaller depth to the dummy joints, or placing an additional mat of steel within the joints closer to the surface.

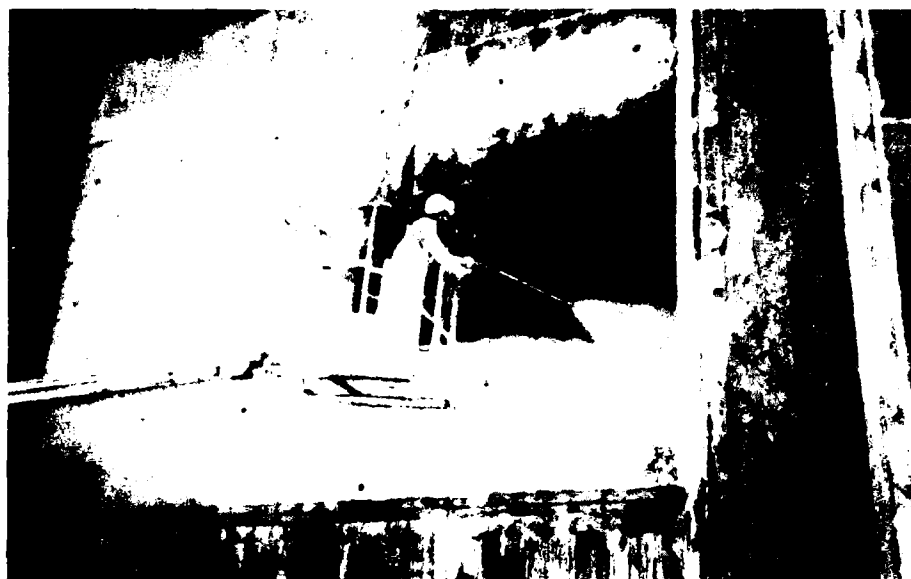
221. After the forms were removed, generally at 1 to 3 days following concrete placement, the contractor had the option of using either moist-curing or a membrane curing compound conforming to CRD-C 300. Membrane curing was used predominantly because of the cold weather conditions. Following application of the curing compound, a polyethylene sheet was draped over the concrete surface for the duration of the curing period (Figure 98).

Figure 98. Typical curing of concrete resurfacing,
Lock No. 1, Mississippi River

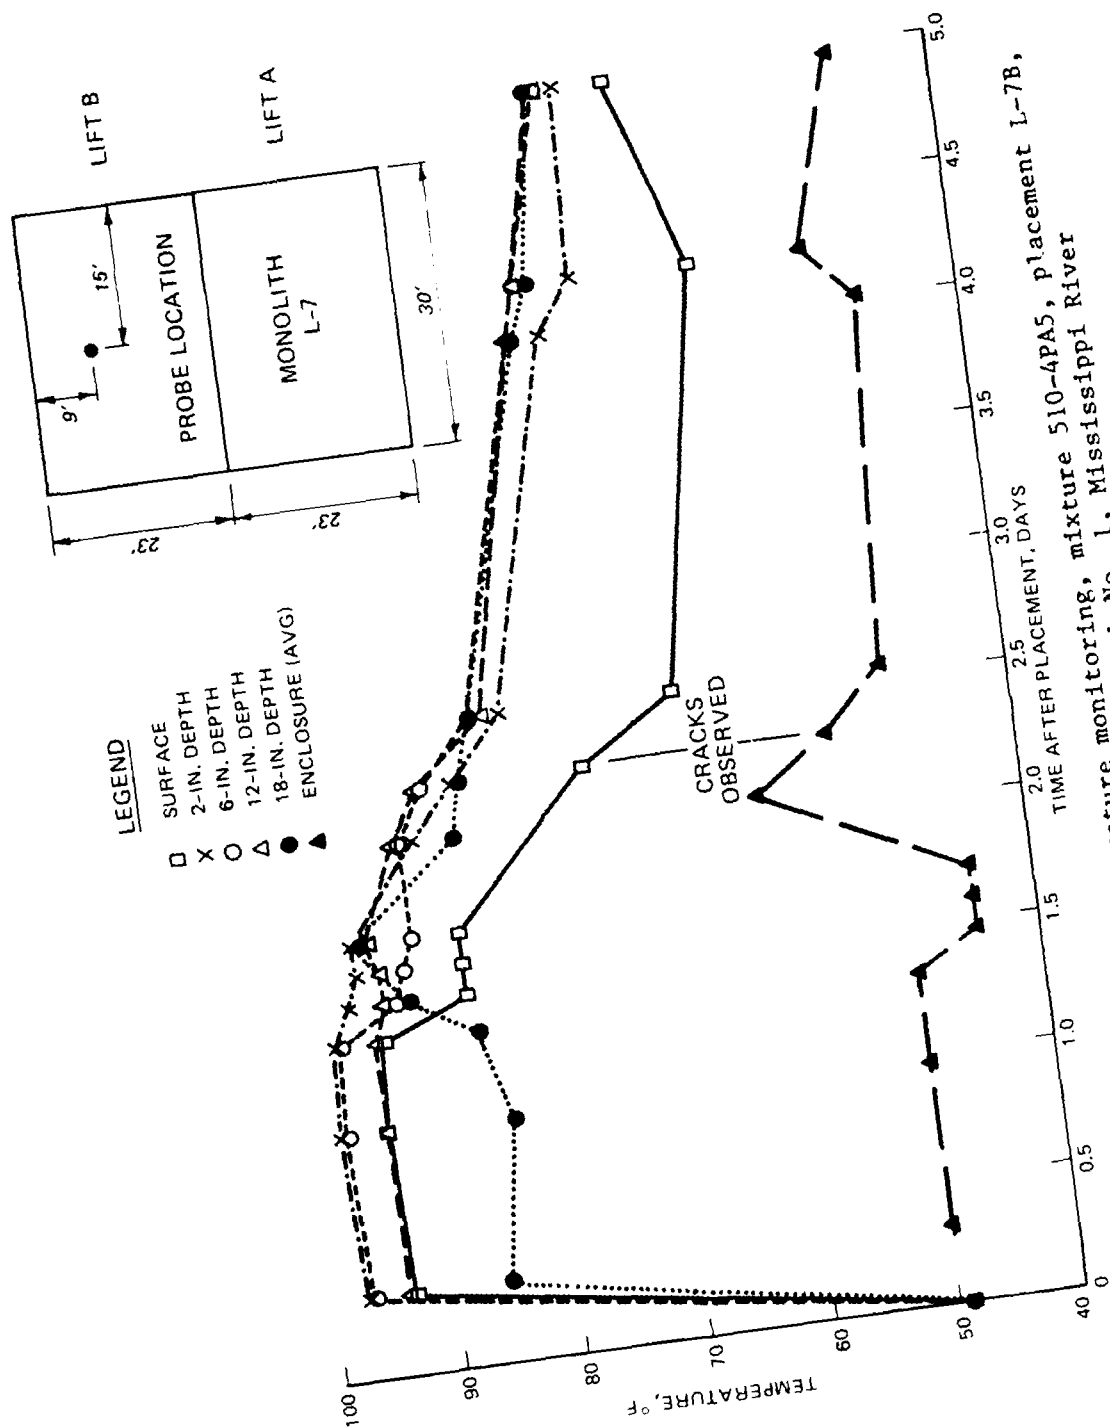
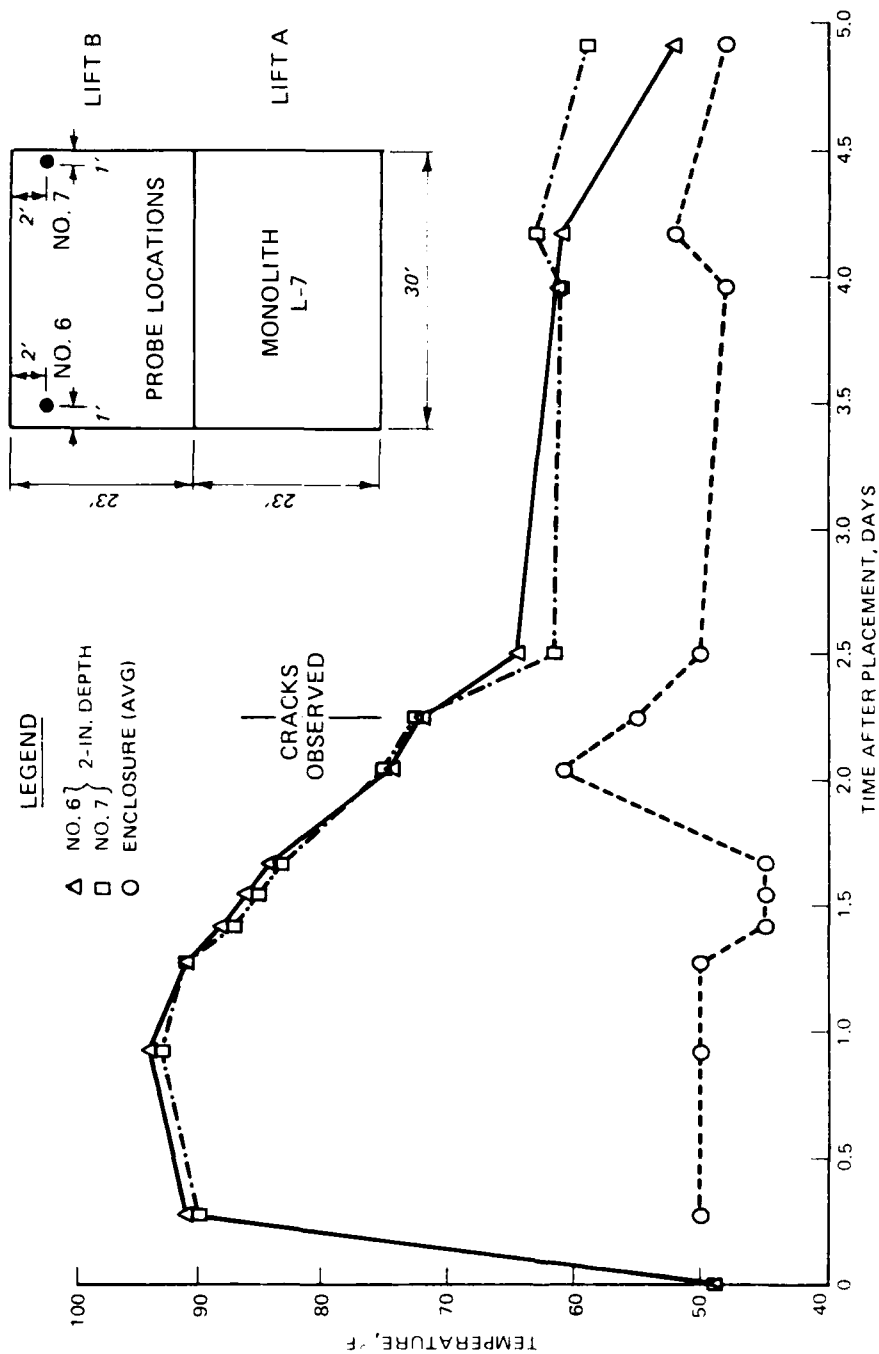
223. Results of the temperature monitoring of placement L-7B are shown in Figures 99 and 100. Although the form was not removed until 6 days after the concrete was placed, cracks were observed on top of the lift during the second day after placement. Temperature probes were located at two levels within the placement, 2 and 9 ft below the top of the lift. Peak concrete temperatures, approximately 24 hr after placement, were 95° and 98°F for the upper and lower levels, respectively, or 45° and 48°F higher than the average enclosure temperature. At the same time, the concrete surface temperature on top of the lift was reported to be 68°F. At the time cracks were observed, the temperature differential between ambient and concrete at 2-in. depth as measured from the wall face was 17° and 30°F for the upper and lower level probes, respectively. However, a temperature probe embedded 2 in. below the exposed top of the lift would have provided a more meaningful comparison in this case where the form was left in place for an extended period.

Figure 99. Results of temperature monitoring, mixture 510-4PA5, placement L-7B, 9 ft below top of lift B, Lock No. 1, Mississippi River

Figure 100. Results of temperature monitoring, mixture 510-4PA5, placement L-7B, 2 ft below top of lift B, Lock No. 1, Mississippi River

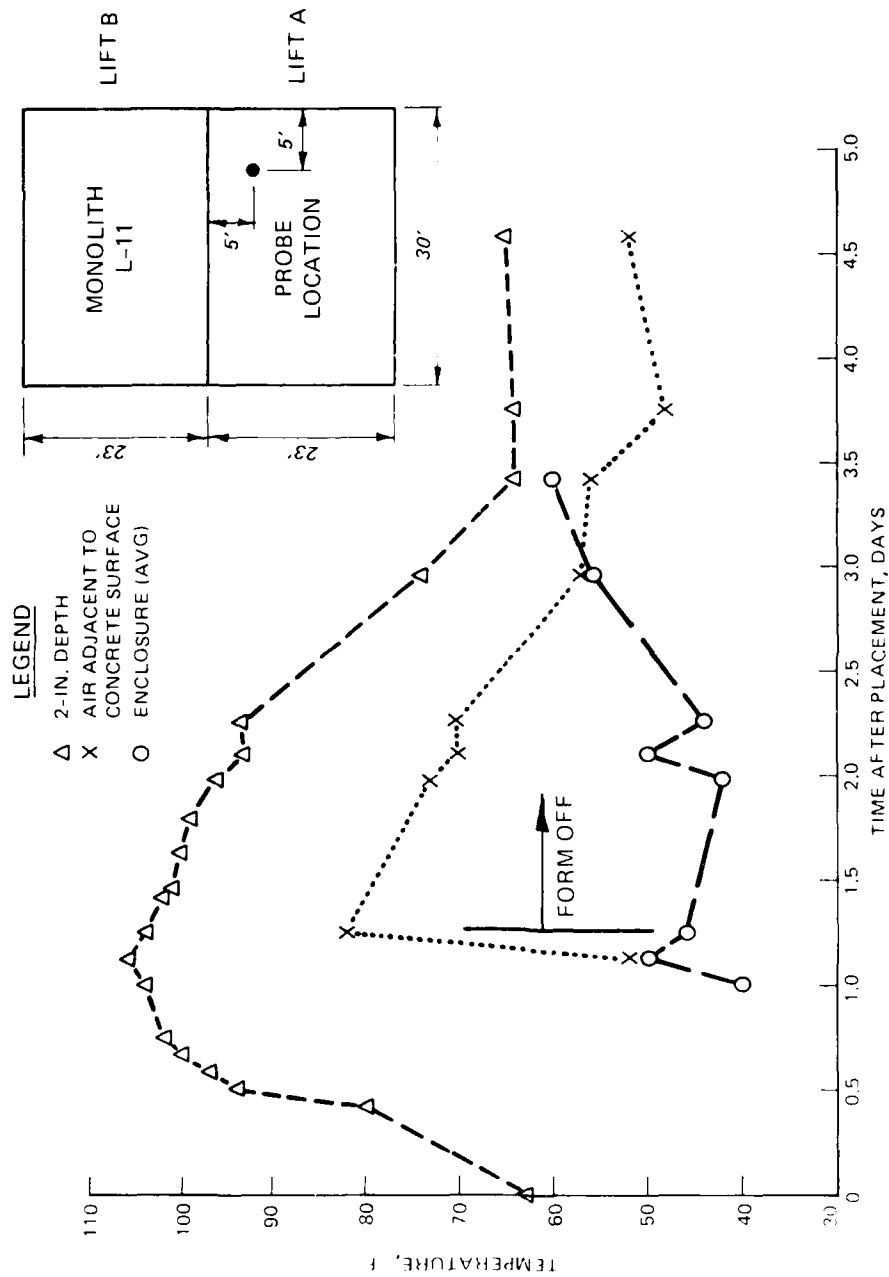
224. Results of temperature monitoring of placement L-11A are shown in Figure 101. A peak temperature of 106°F was recorded, 27 hr after placement, which represents a heat rise of 43°F. The form was removed at this point subjecting the concrete to a temperature differential between ambient and 2-in. depth of 56°F. Covering the concrete surface with polyethylene quickly

Figure 101. Results of temperature monitoring, mixture 510-4PA5, placement L-11A, Lock No. 1, Mississippi River

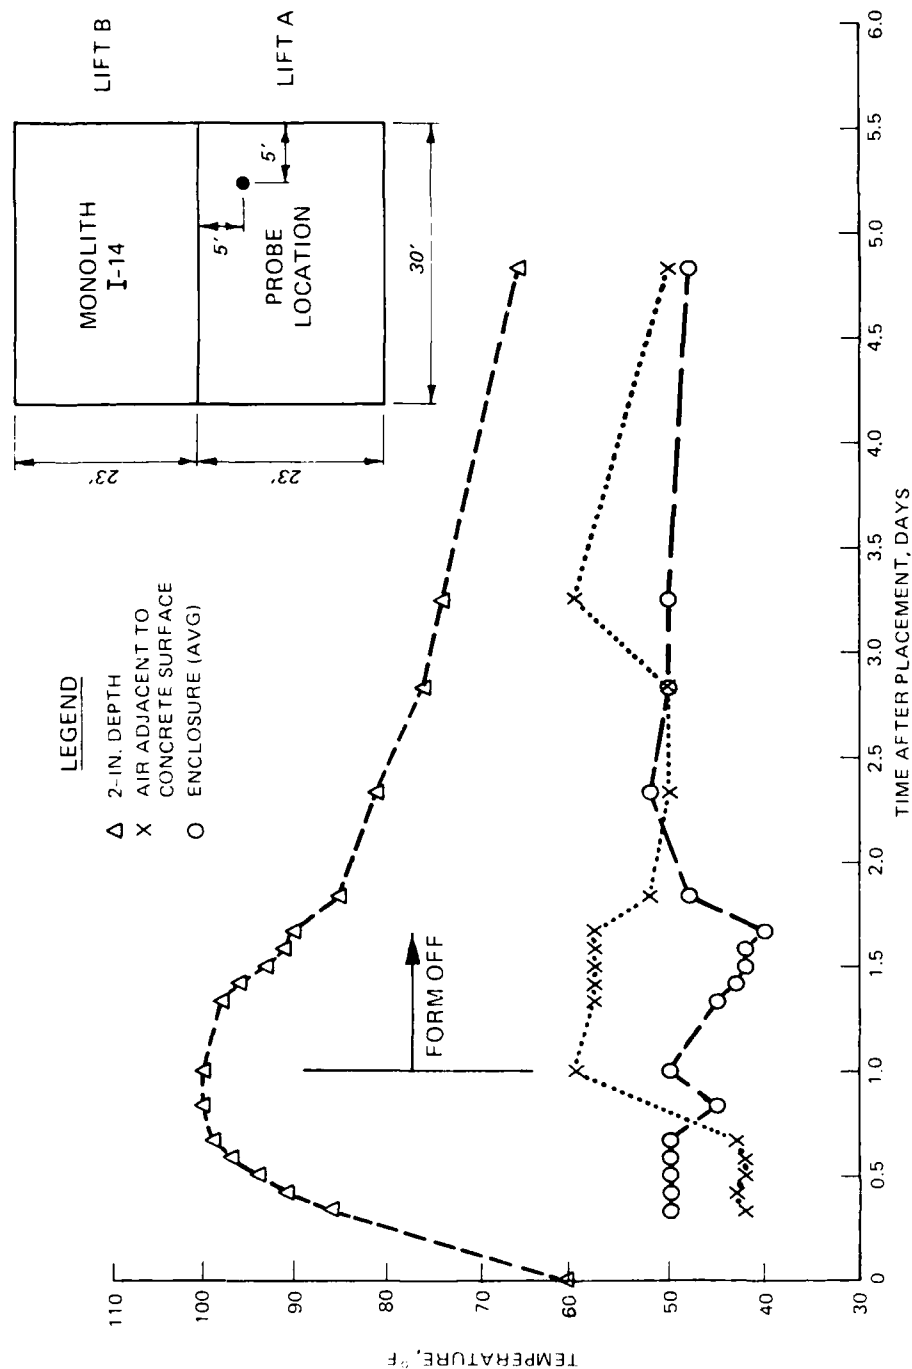
Figure 102. Results of temperature monitoring, mixture 510-4PA5, placement I-14A, Lock No. 1, Mississippi River

reduced the temperature differential between air adjacent to the surface and at 2-in. depth inside the concrete to 22°F. Similar results were obtained for placement I-14A (Figure 102). The form was removed one day following placement, subjecting the concrete to a temperature differential between ambient and 2-in. depth of 55°F. After the concrete surface was covered with polyethylene, the temperature differential between air adjacent to the surface and concrete at 2-in. depth was 40°F. This temperature differential decreased with time; however it remained in excess of 25°F for approximately two days. Although no cracks were reported for either the L-11A or I-14A placements, it is quite possible that they were present but not observed because of the polyethylene covering. Later reports that most placements contained cracks would appear to substantiate this possibility.

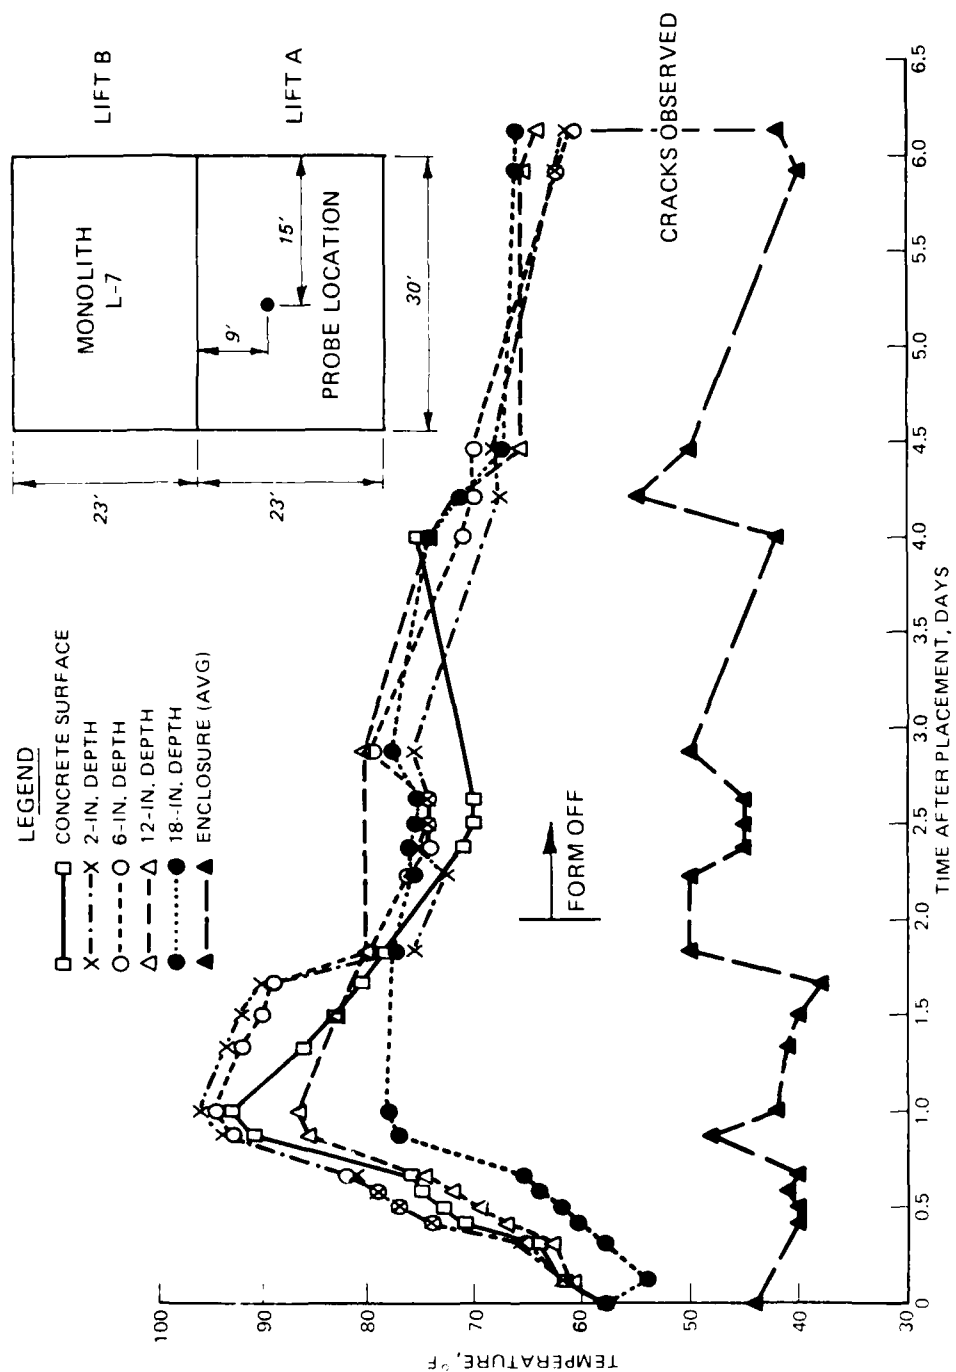
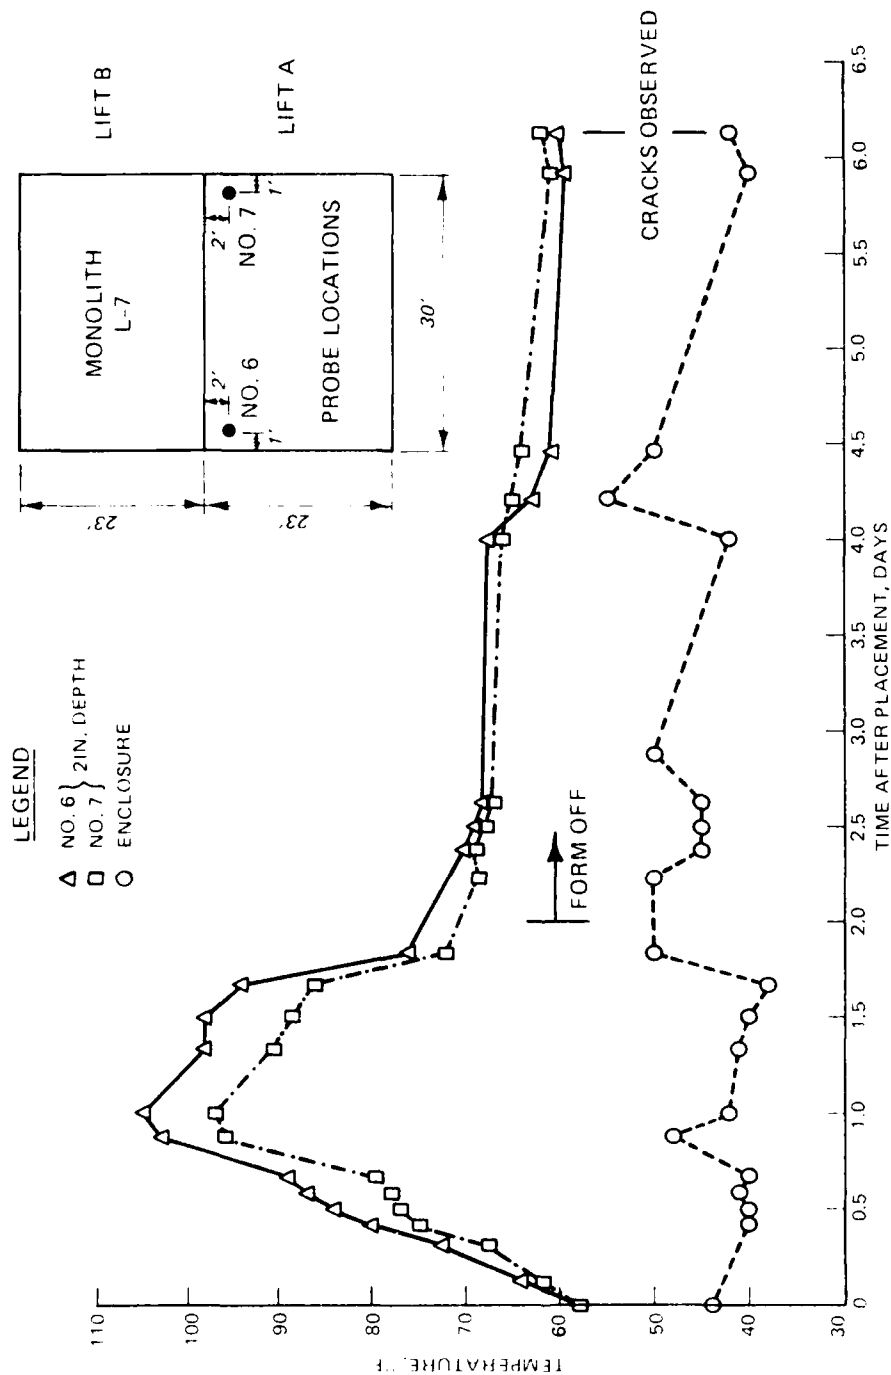
230. Results of the temperature monitoring of placement L-7A are shown in Figures 103 and 104. The peak temperature recorded, 24 hr following placement, was 96°F, which represented a heat rise of 38°F. From removal two days after placement, the concrete was subjected to a temperature differential between ambient and 2-in. depth of 25°F. This differential decreased only slightly during the remainder of the curing period. Cracking similar to that previously observed in the conventional concrete resurfacing was reported. The cracks were not observed until the end of the curing period.

Figure 103. Results of temperature monitoring, mixture CC552-4PA5, placement L-7A, 9 ft below top of lift A, Lock No. 1, Mississippi River

Figure 104. Results of temperature monitoring, mixture CC552-4PA5, placement L-7A, 2 ft below top of lift A, Lock No. 1, Mississippi River

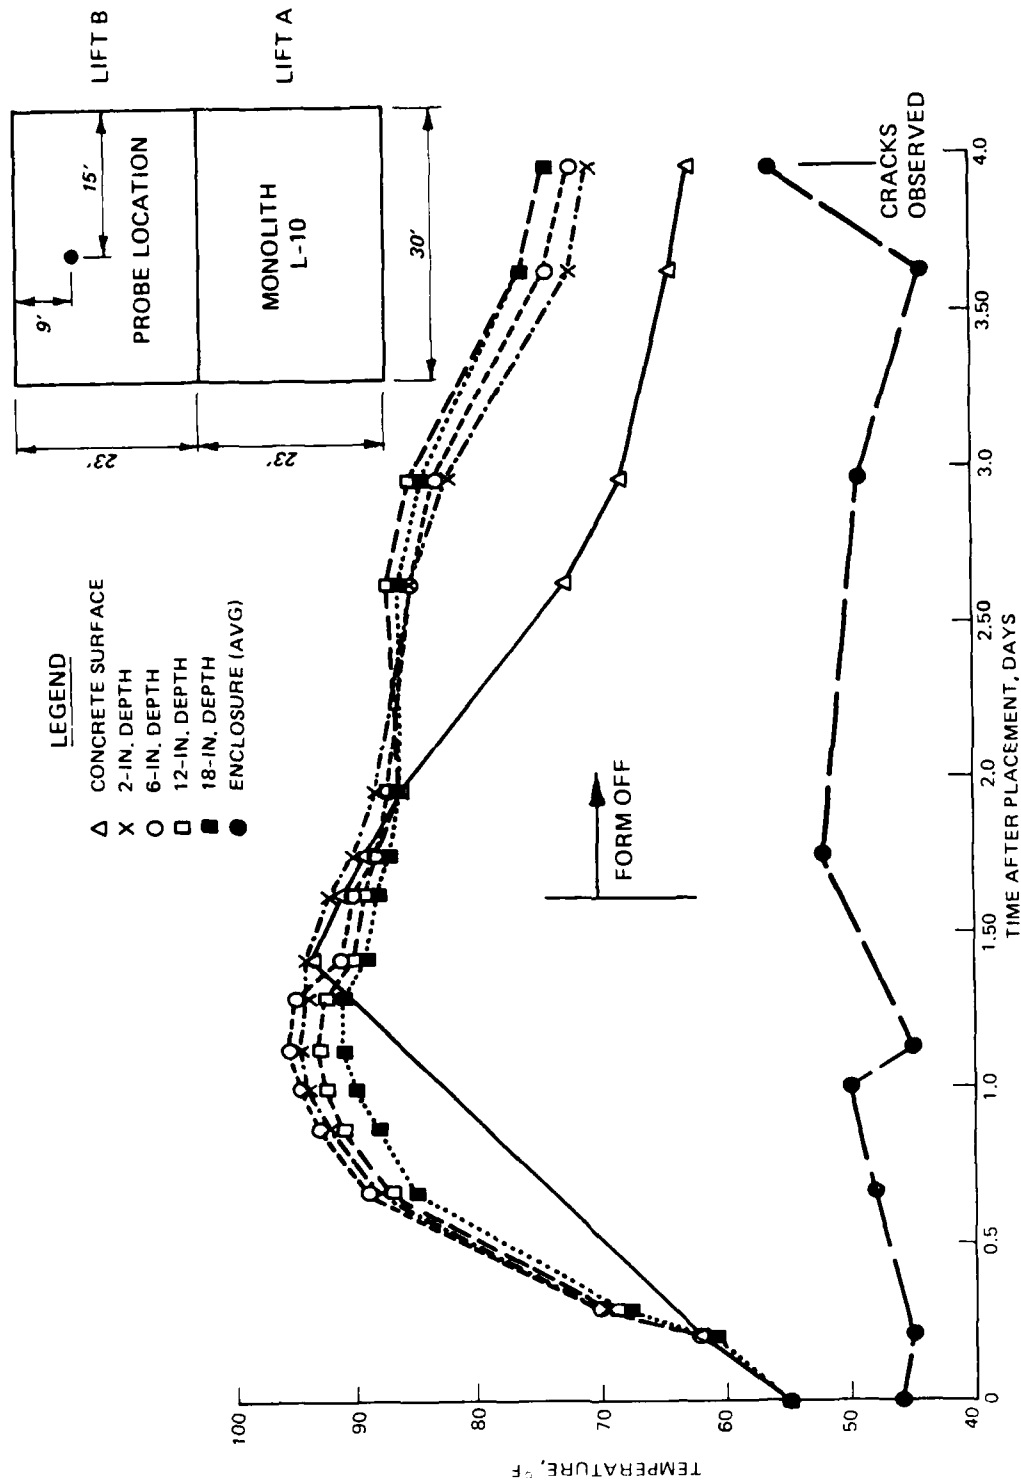
233. Results of the temperature monitoring of placement L-10B are shown in Figure 105. The peak temperature recorded, 27 hr following placement, was 96°F which represented a heat rise of 41°F. At the time of form removal, approximately 1-1/2 days after placement, the concrete was subjected to a temperature differential between ambient and 2-in. depth of approximately 40°F. This differential exceeded 25°F for two days following form removal. Although cracks were not observed until four days after placement, it was noted that they may have occurred earlier.

Figure 105. Results of temperature monitoring, mixture 78x517-4P5A5, placement L-10B, Lock No. 1, Mississippi River

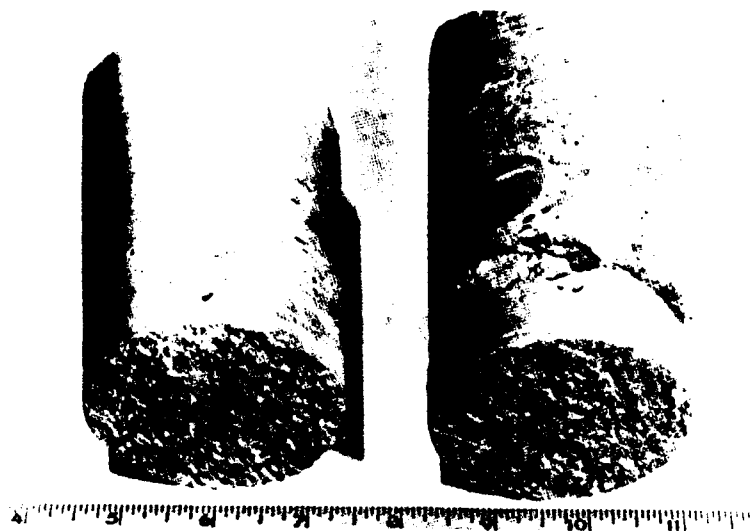
- (6) Mixture 6. No fine cracks were observed in this section. No debonded areas were evident on the upper lifts, but numerous hollow sounding areas were present in lower lift sections, with some sections having completely peeled off in large sheets. However, immediately next to some of the peeled-off areas, the bond of the coating to the substrate was excellent. As with all other sections, the surfaces of sections coated with Mixtures 5 and 6 showed essentially no change in appearance from the previous summer. Visual examinations of cores (Figure 111) indicated that hollow sounding areas were, in fact, delaminated, and the anticipated well-bonded zones were found to be sound. These observations confirmed that the debonding failures were caused by improper surface preparation. The coatings in such instances were found to be bonded to the mortar from the original (unsound) surface, but the weak surface mortar had peeled away from the rest of the concrete, thereby causing the failure.

Figure 111. Typical horizontal cores from test sections showing excellent bond (left) and bond failure at shotcrete-concrete interface (right) due to improper surface preparation, Lower Monumental Lock

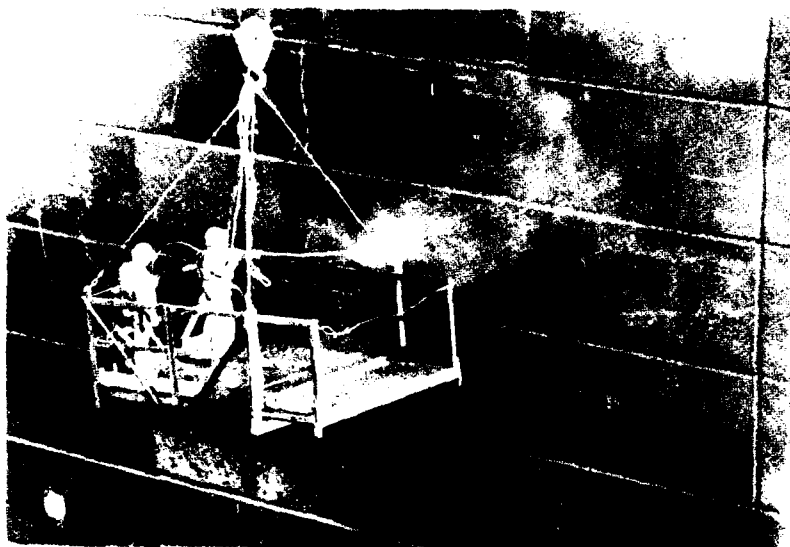
Figure 112. Removal of unsound concrete mortar using a high-pressure water jet, Lower Monumental Lock

the lock chamber walls. Since the success of the repair was totally dependent upon satisfactory surface preparation, several additional surface cleaning trials were made to verify that with properly operating high-pressure water-jet equipment, the surface could be satisfactorily cleaned. Sandblasting equipment, wire brushes, hand chipping, and air-operated scabblers were also tried by the Government designers. The benefit of this experience was passed on to the bidders through a prebid conference, discussion in the technical provisions of the bidding documents, and with photographs of the work (Figure 112) which also became a part of the bidding documents.

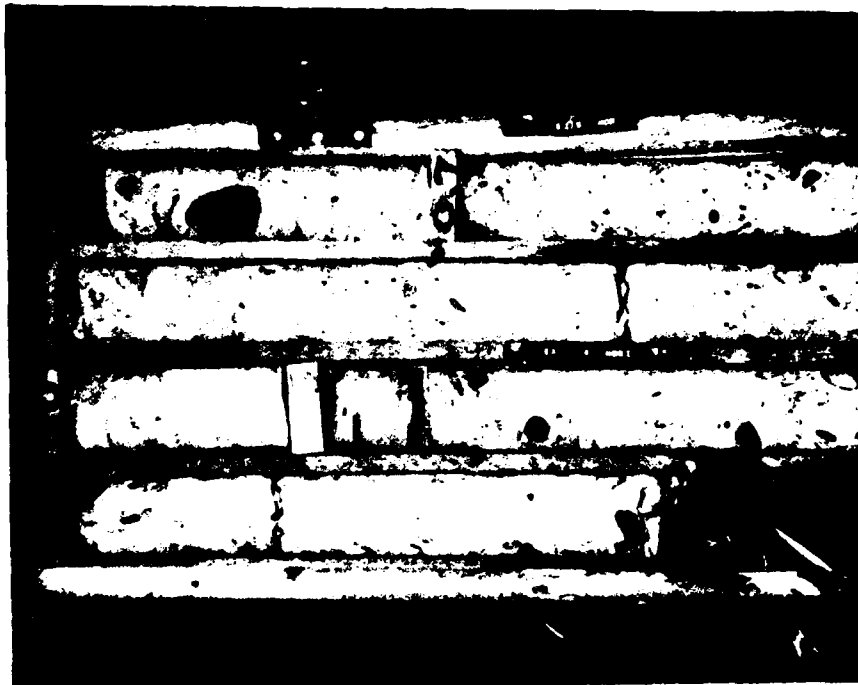
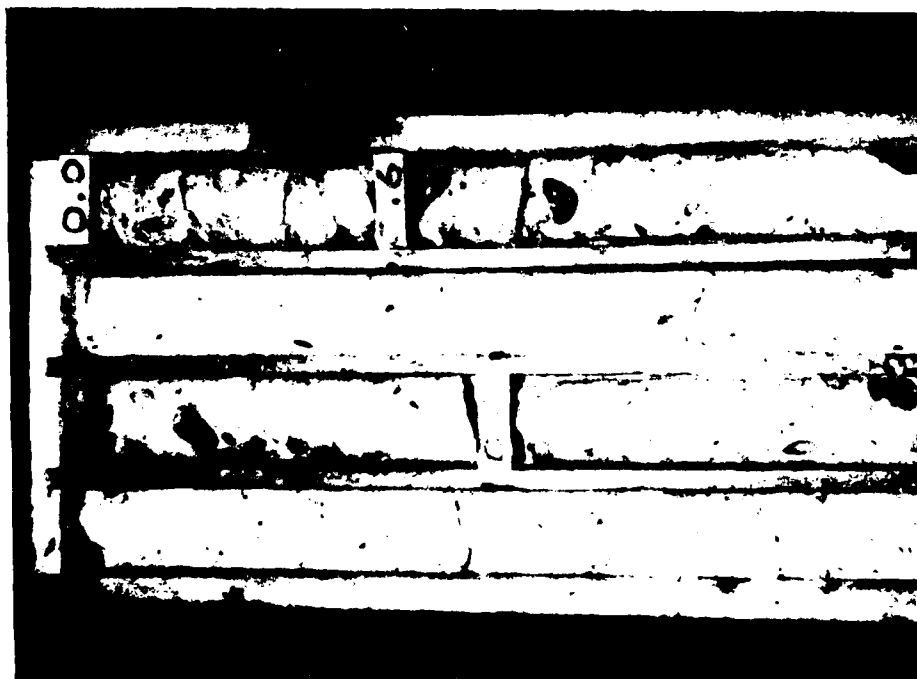
288. During this inspection, horizontal cores drilled from the lock chamber walls in 1973 were compared. Cores from the river chamber showed the shotcrete to be in generally good condition (Figure 130); however the original concrete behind the shotcrete exhibited significant deterioration probably caused by cycles of freezing and thawing. Cores of similar concrete from the land chamber which were not coated with shotcrete were in generally good condition from the surface inward (Figure 131). These cores appear to be an example of an exterior coating contributing to the saturation of the original concrete with increased deterioration caused by frost action as a result.

Figure 130. Horizontal cores taken from the river
chamber walls, 1973, Emsworth Locks

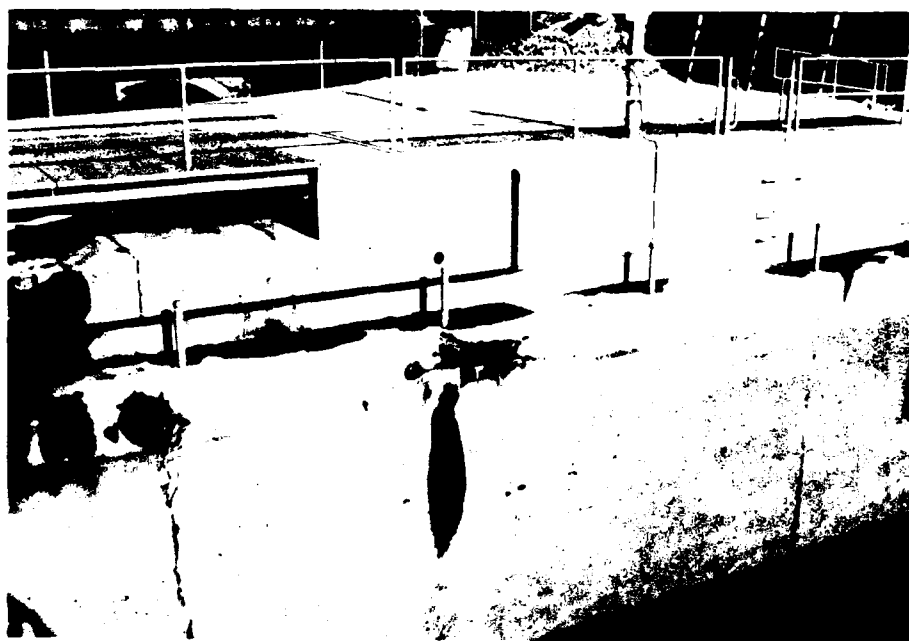
80 percent of the shotcrete coating on monoliths L-37 and L-38 between elevations 692 and 703 was missing to depths of up to 2 in. The coating on monolith L-39 contained a reflective vertical crack which was also present in the concrete below the lower limit of the shotcrete coating. The monolith joint and ladder-way repairs were in good condition. The shotcrete coating applied in the gate recesses was in poor condition with numerous horizontal and diagonal cracks (Figure 136). The majority of these cracks, which ranged in width

Figure 136. Cracking in shotcrete coating, downstream gate recess, land wall, December 1985, Emsworth Locks

from fine to wide, were located above upper pool elevation. According to lock personnel, these cracks occurred almost immediately after shotcreting, perhaps because of the prevailing hot, dry wind at the time of placement. Efflorescence was associated with a number of these cracks. A few cracks were dampened by water, and in several places water seepage through cracks in the coating covered large areas of the coating. Small areas of the shotcrete coating were debonded from the underlying concrete.

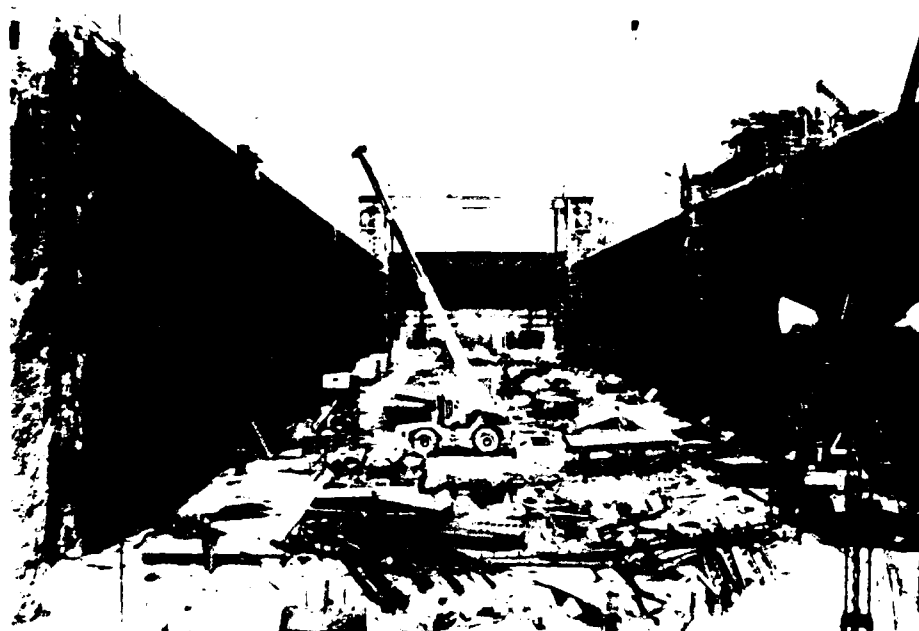
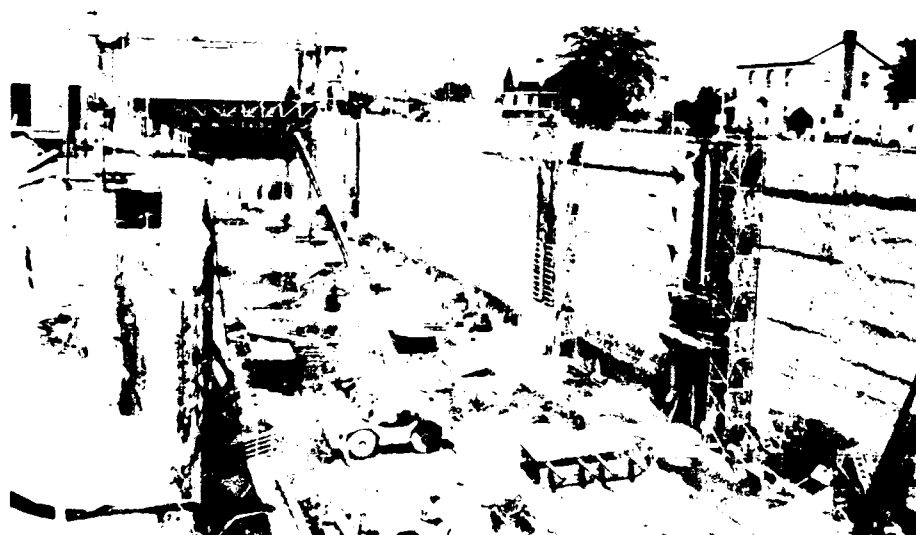
compared to the Government estimate of \$8.0 million. An abstract of the bids is shown in Appendix A. The major work items under this contract were complete replacement of the lower miter gates and machinery, stabilization of the upper service gate sill, modifications to the upper lift gates, modification of the electrical distribution system, and miscellaneous concrete resurfacing (Figure 139).

Figure 139. Stage I rehabilitation, Lockport Lock

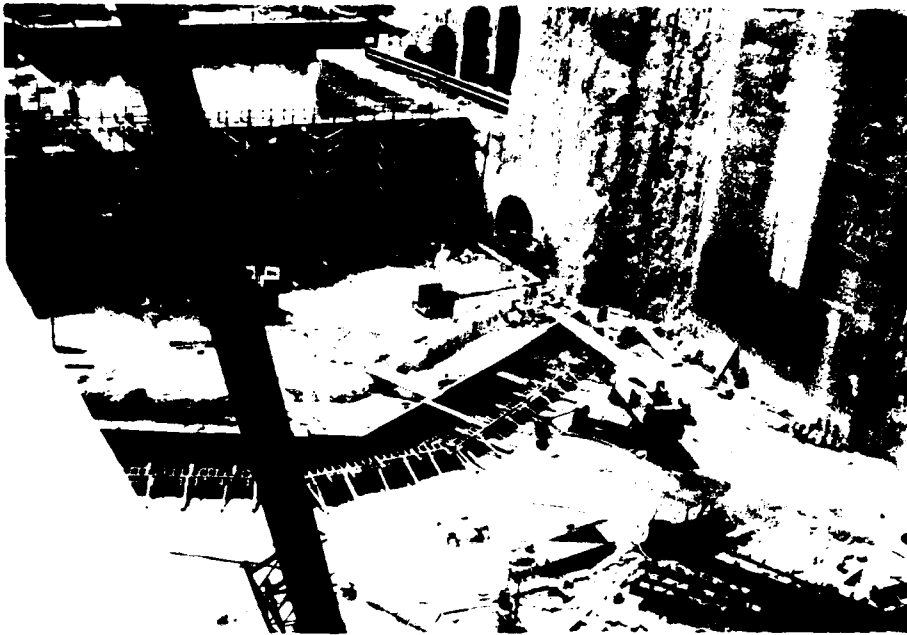
Figure 140. Miter gate sill and anchorage, modifications,
Lockport Lock

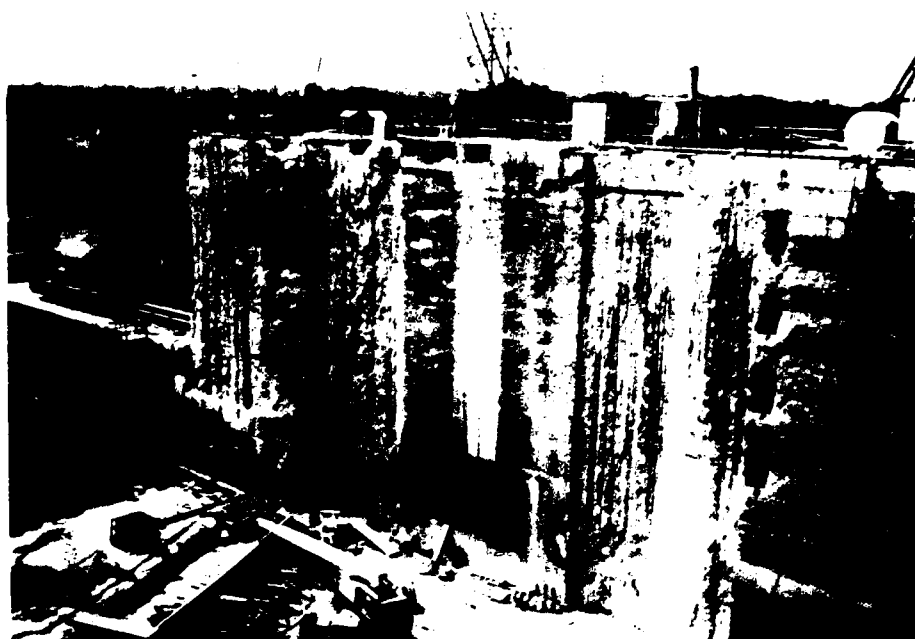
Figure 141. Lock chamber modifications to accommodate new miter gates, Lockport Lock

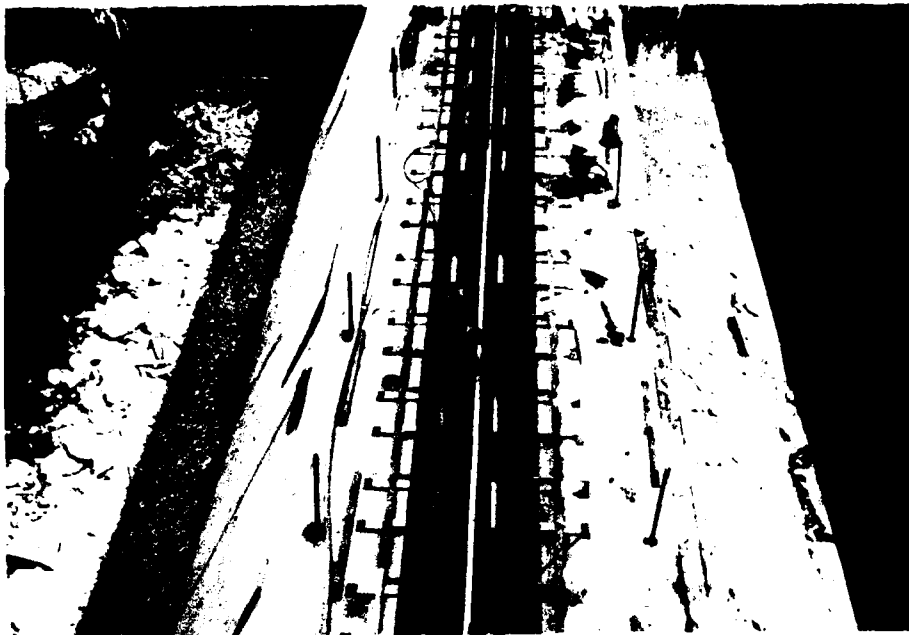
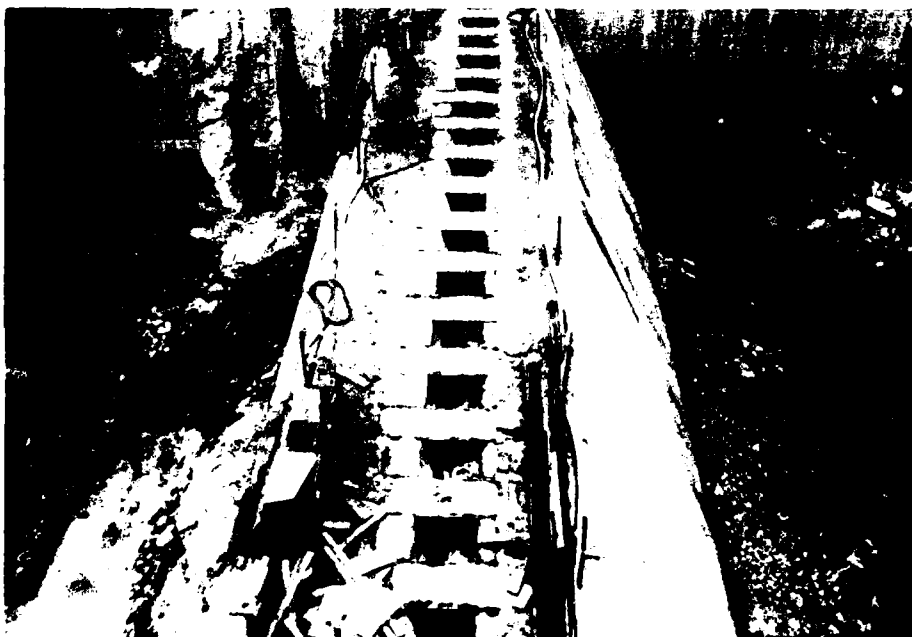
the sill. After reinforcement was installed, blockouts for anchor recesses were formed, and concrete was placed to original grade (Figure 145). A concrete mixture (Type A) proportioned for a slump of 1 to 4 in., an air content of $6 \pm 1\frac{1}{2}$ percent, and 4,000-psi compressive strength at 7 days age was used in gate stabilization work. Concrete mixture proportions for a 1-cu yd batch were as follows:

Figure 145. Modification of upper service gate sill prior to installation of rock anchors, Lockport Lock

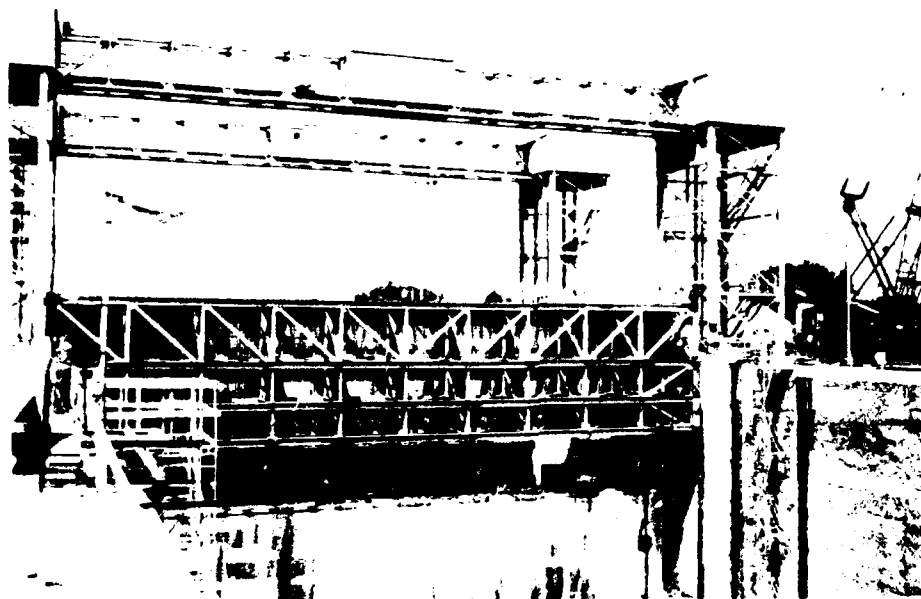
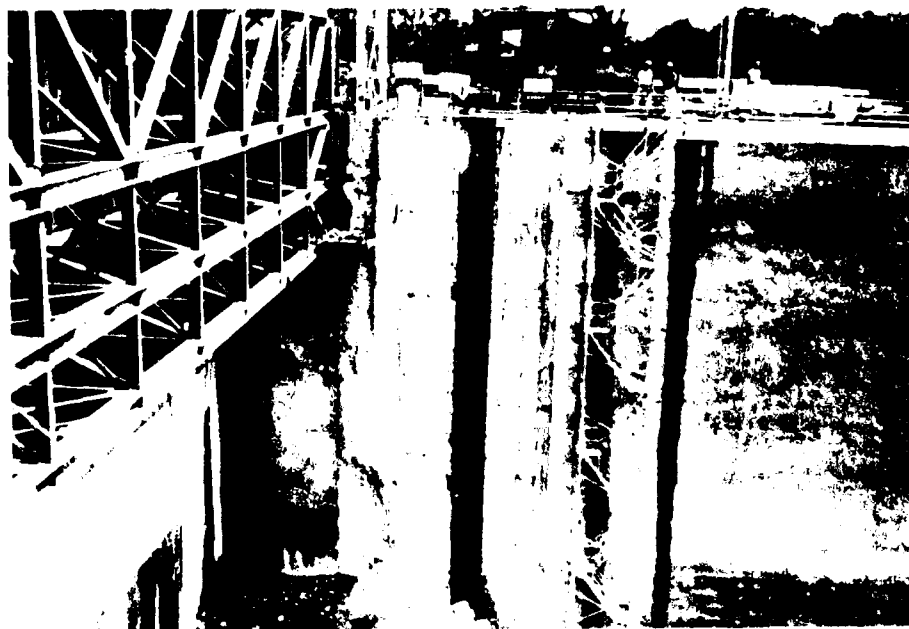
318. The present lifting system for the upper lift gates at Lockport does not allow operation of the gates under a differential head. Emergency closure was deemed necessary to prevent loss of upper pool during a lower miter gate failure from barge impact. The gates were modified as part of Stage I by enlarging the gate recesses (Figure 147) and replacing the friction pads on the gates with rollers. The future installation of new gate machinery (Stage III) will result in the capability of operating the gates under differential head.

Figure 147. Upper service gate modifications, Lockport Lock

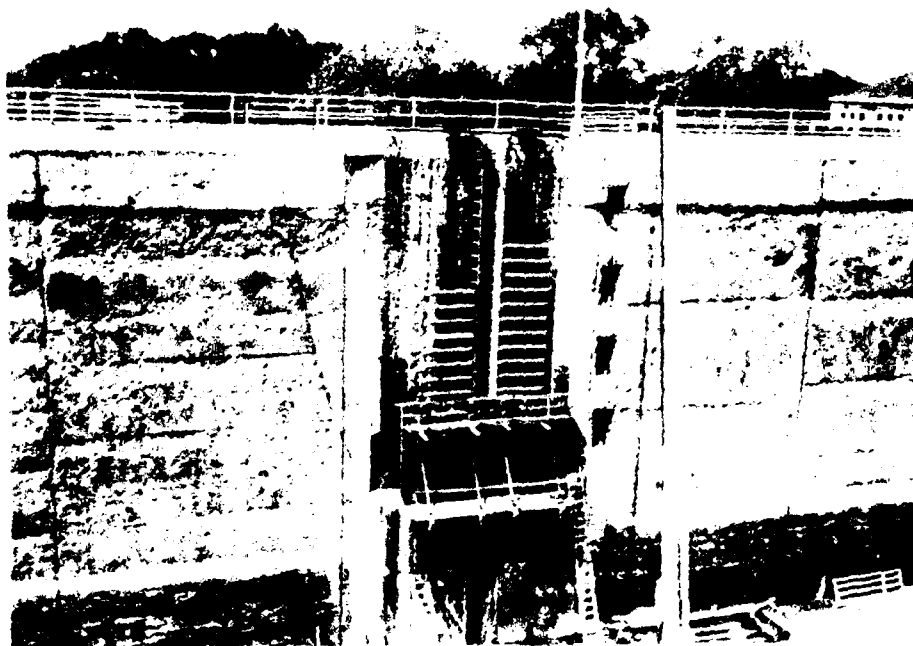
Figure 152. Overbreak area prepared for repair,
Lockport Lock

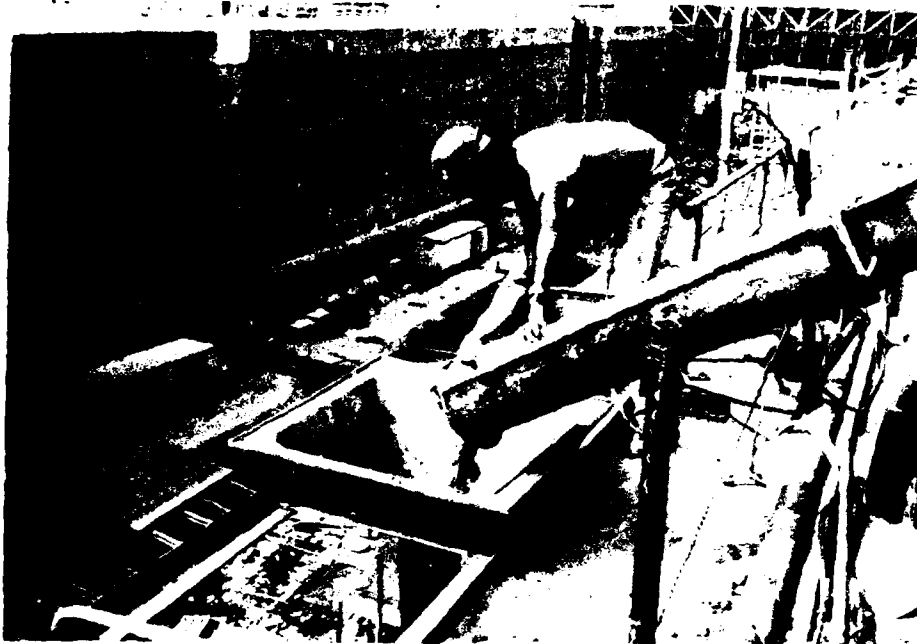
Figure 153. Placing concrete on the landside wall,
Lockport Lock
